ERDMAN ANTHONY ASSOCIATES ROCHESTER NY  
NATIONAL DAM SAFETY PROGRAM. DAVIS BROOK DAM (SITE 1) (INVENTOR--ETC(U)  
AUG 81 R J FARRELL

REPORT DOCUMENTATION PAGE		READ INSTRUCTIONS BEFORE COMPLETING FORM
1. REPORT NUMBER	2. GOVT ACCESSION NO. AD-A405742	3. RECIPIENT'S CATALOG NUMBER
4. TITLE (and Subtitle) Phase I Inspection Report Davis Brook Dam Allegheny River Basin, Cattaraugus County, NY Inventory No. 564		5. TYPE OF REPORT & PERIOD COVERED Phase I Inspection Report National Dam Safety Program

17. DISTRIBUTION STATEMENT (of the abstract entered in Block 20, if different from Report)  National Dam Safety Program. Davis Brook Dam (Site 1) (Inventory Number N.Y. 564), Allegheny River Basin, Conewango Creek Watershed, Cattaraugus County, New York. Phase I Inspection Report.

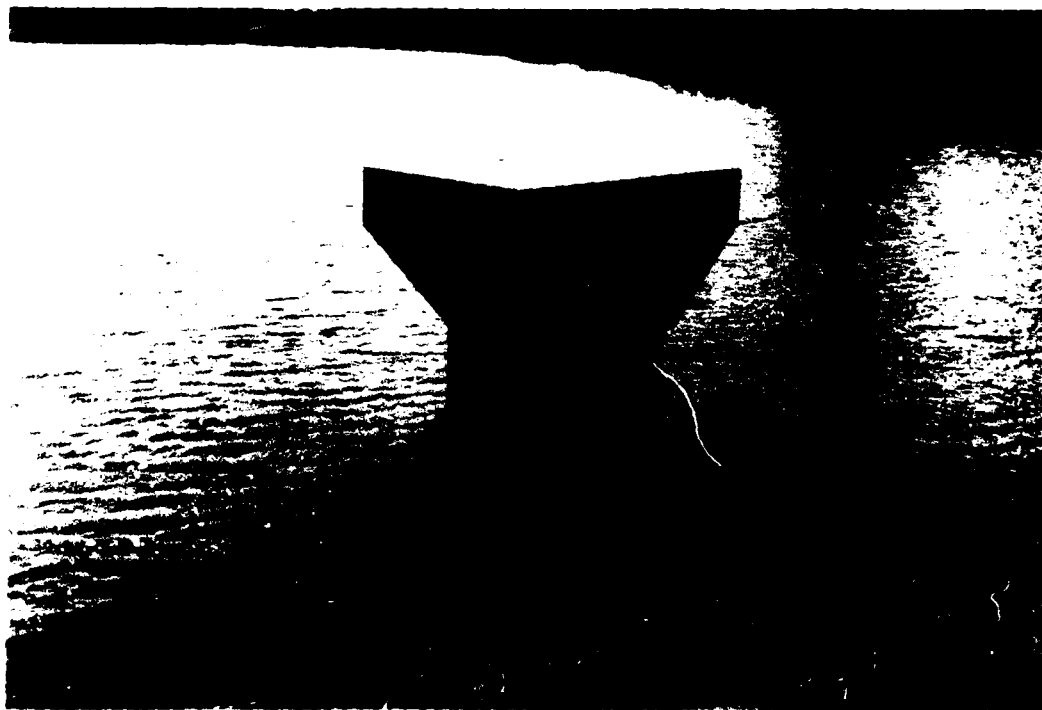
The structure is in good condition with no evidence of spalling, cracking, or efflorescence. The trash racks are in good condition, and free from debris accumulation.

2. Principal spillway inlet structure showing low stage inlet and trash rack
